# Manhole Inspection Summary

Manhole # S13A\_\_037MH

Insp Date: **1/14/09 1:56 PM**

**Location** Address: **2810 LANVALE ST**

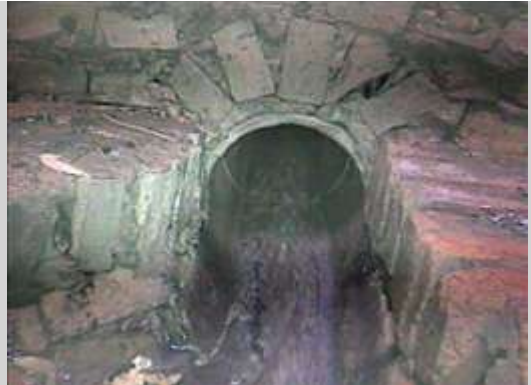
12 O'Clock Outflow

8 in. Circular Gravity Sewer  
Pipe Out @ 12 O'Clock

Pipe Height: (in.) Direct  
Pipe Material: **Clay** ☐ Pipe Lined  
Invert Depth: **7.20** (ft.) Flow Characteristics: **Fast**  
Deposits: ☒ None ☐ Mud ☐ Sludge ☐ Debris ☐ Grease  
Silt Depth: (in.) Deposits Extent:  
Infiltration: **None** Pipe Seal Cond: **Sound**

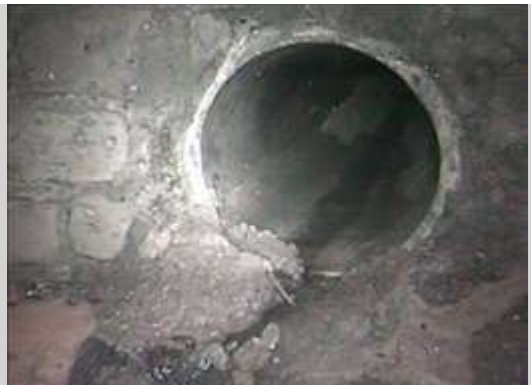
3 O'Clock Inflow

8 in. Circular Gravity Sewer  
Pipe In @ 3 O'Clock

Pipe Height: (in.) Direct  
Pipe Material: **Clay** ☐ Pipe Lined  
Invert Depth: **6.70** (ft.) Flow Characteristics: **None**  
Deposits: ☒ None ☐ Mud ☐ Sludge ☐ Debris ☐ Grease  
Silt Depth: (in.) Deposits Extent:  
Infiltration: **None** Pipe Seal Cond: **Sound**

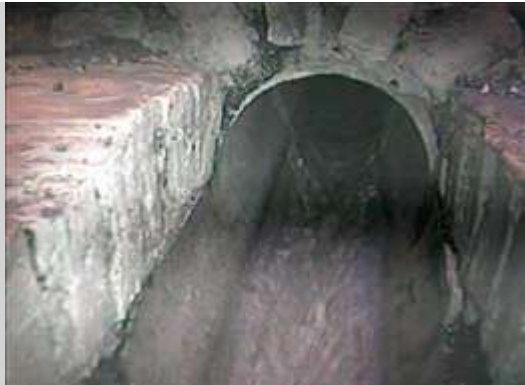
6 O'Clock Inflow

Pipe In @ 6 O'Clock

Infiltration: **None** Pipe Seal Cond: **Sound**

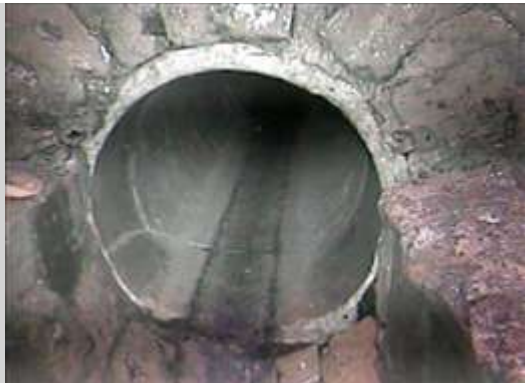
9 O'Clock Inflow

Pipe In @ 9 O'Clock

Infiltration: **None** Pipe Seal Cond: **Sound**
